WORKPLACE HEALTH SAFETY AUDIT

SAMPLE REPORT

1 SMITH STREET
SYDNEY

SP 00000

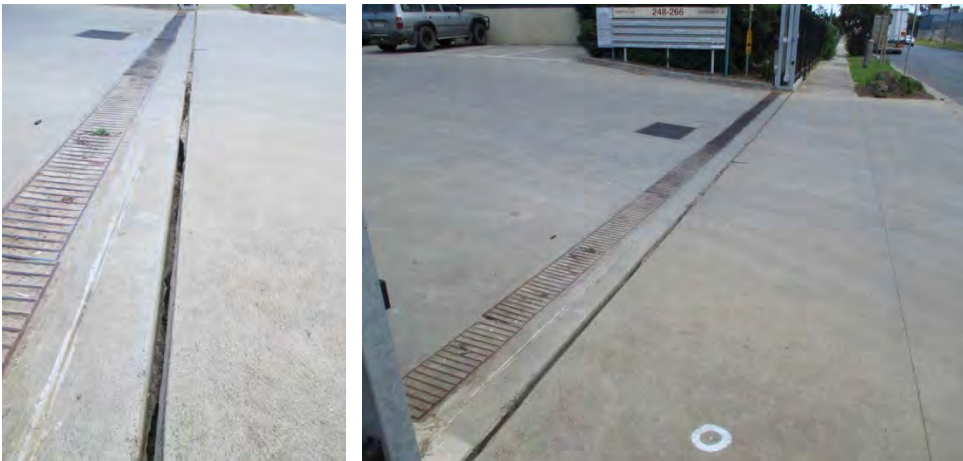
Item 1: Gap between driveway slabs – Main entrance

Hazard: There is a gap of up to 40 mm between the driveway and crossover slab. There is a risk that a person will trip and fall if they step on the gap (particularly if the heel of a woman's shoe becomes wedged in the gap). The gap runs along the alignment of the public path and could affect people associated with the scheme as well as general pedestrians.

Recommended action: Fill the gap with an appropriate filler.

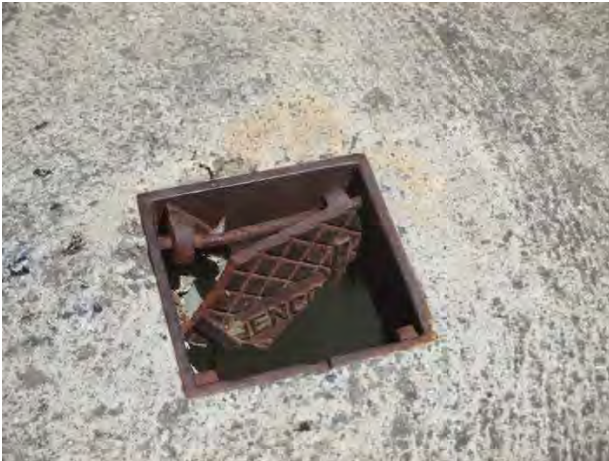
Item 2: Broken service cover – Main driveway

Hazard: The service cover has broken, leaving most of the service pipe uncovered. There is a risk that a person will trip on the hole and fall.

Recommended action: Replace the service cover

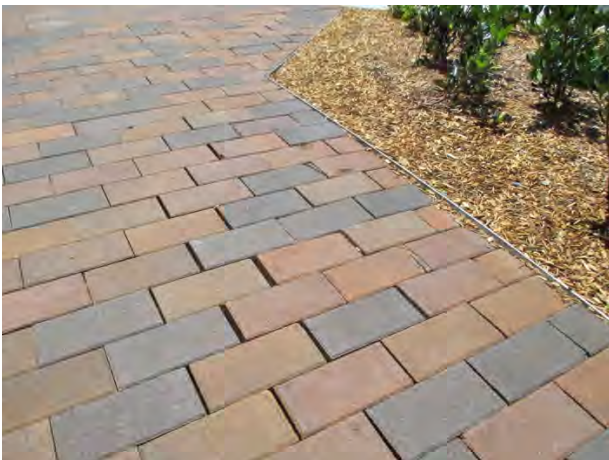
Item 3: Uneven paving – Footpath to pool

Hazard: The surface of the brick paving is uneven, and gaps are starting to develop between some of the pavers. There is a risk a person will trip on the uneven surface and fall.

Recommended action: Relay the pavers to create an even surface.

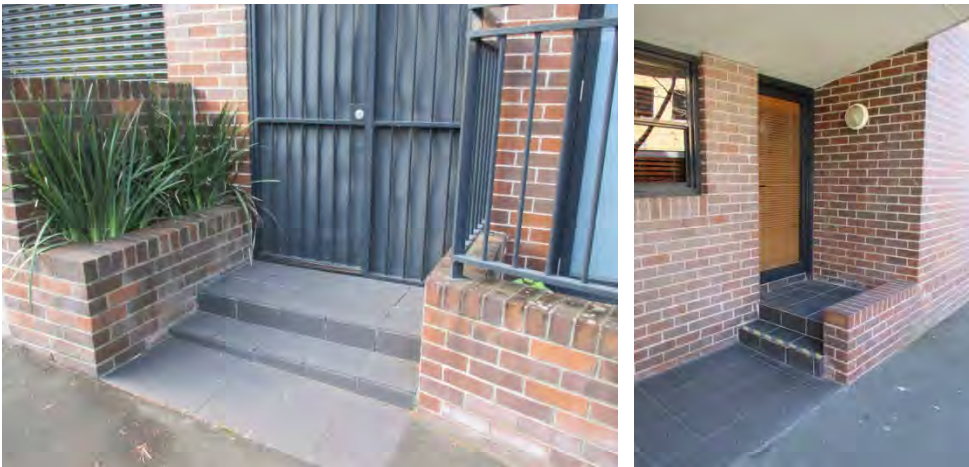
Item 4: Missing handrails & landing without edge protection – Entries from street level

Hazard: There are two sets of stairs that do not have a handrail. One entry also has an approximately 600 mm high landing with no edge protection. There is an increased risk that a person will lose their balance on the stairs and fall because they do not have a handrail onto which they can hold. There is also a risk that a person standing on the landing will step back while opening the door (particularly while moving a bulky item in or out), trip on the brick upstand, and then fall over the edge.

Recommended action: Install Building Code of Australia compliant handrails. Install a balustrade/barrier along the top of the brick wall at the edge of the landing.

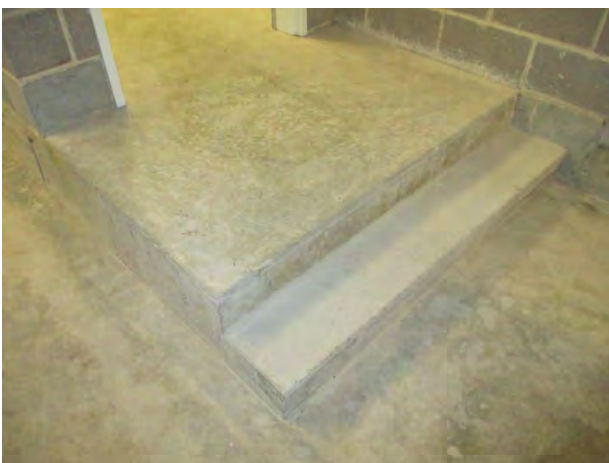
Item 5: Missing handrail – Basement entry steps

Hazard: There are two steps at the entry to the basement that do not have a handrail or edge balustrade. There is an increased risk that a person will lose their balance on the steps and fall because they do not have a handrail onto which they can hold. There is also a risk that people will lose their balance and fall if they attempt to step up or down directly over the landing edge.

Recommended action: Install a Building Code of Australia compliant handrail and extend it along the full length of the landing to the wall.

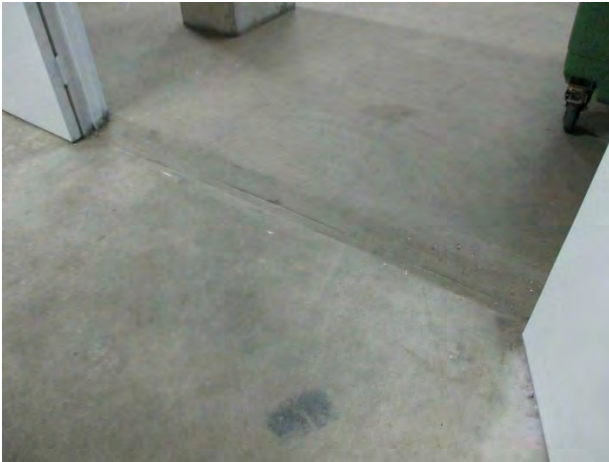
Item 6: Step to garbage holding room – Ground level

Hazard: There is a 50 mm high change in floor level at the garbage room door threshold. The change in level has a ramped edge, but the ramp has a steep

slope. There is a risk that a person will overlook the change in level, causing them to trip and fall.

6	Step to garbage holding room	Ground level				*				*			2	At minimum, highlight the ramped edge with safety paint. Preferably, also grind the ramped edge down to create a gentler slope.

Recommended action: At minimum, highlight the ramped edge with safety paint. Preferably, also grind the ramped edge down to create a gentler slope.

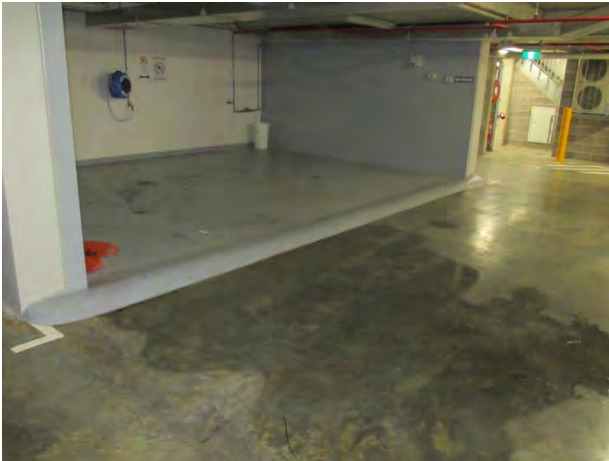
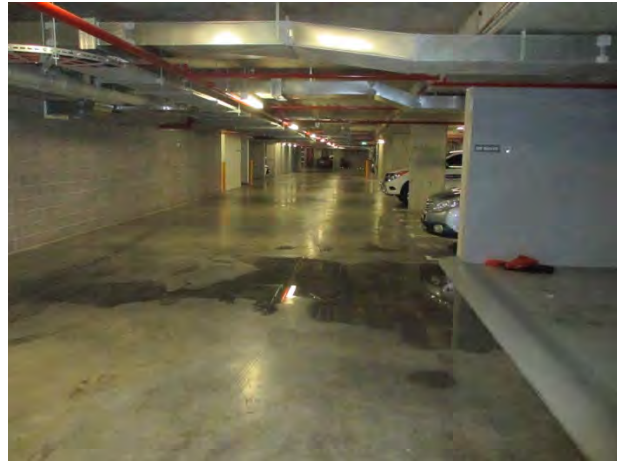
Item 7: Slippery floor surface – Basement car wash bay

Hazard: At the time of the inspection, there was a large quantity of water on the floor next to the car wash bay. We are advised that an overflow from the bay occurs regularly. There is a risk that a person will slip on the wet surface and fall. This risk is increased because of the potential for oil to have been deposited on the driveway.

Recommended action: Investigate options to reduce the water overflow at the car wash bay (possibly by installing plastic curtains, additional drains or increasing the hump height). In the interim, ensure the driveway is cleaned regularly to prevent the build-up of surface contaminants and place out “caution wet floor” signs while the pooled water is present.

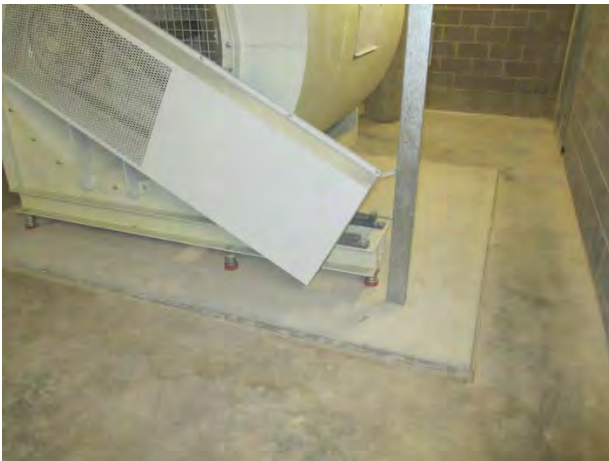
Item 8: Unmarked plinth edges – Basement ventilation room

Hazard: There is a 60 mm high concrete plinth that is the same colour as the surrounding floor. To access the fan controls, people must walk through the narrow floor area between the plinth and the wall. There is a risk that a person will overlook a protruding plinth corner, resulting in them tripping and falling.

Recommended action: Highlight the edge of the plinth with safety paint.

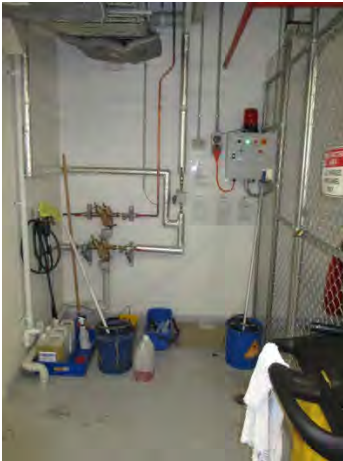
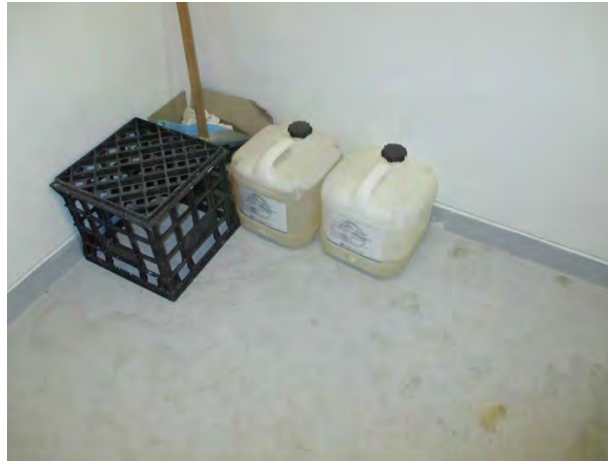
Item 9: Inappropriately stored chemicals – Basement garbage room

Hazard: At the time of the inspection, there were chemicals stored at ground level in the unlocked garbage rooms. There is a risk that an unsupervised child will be poisoned if they ingest these potentially hazardous chemicals.

Recommended action: Remove the chemicals and store them in a locked cupboard/room.

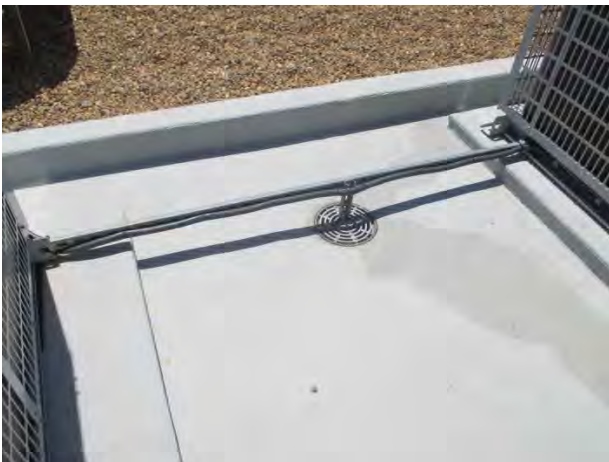
Item 10: Raised pipe running across access way – Roof plant area

Hazard: An air-conditioning pipe runs across a designated accessway at 160 mm above the roof surface. The pipe is a similar colour to the surrounding floor. There is a risk that a person will overlook the pipe, resulting in them tripping and falling.

10	Raised pipe running across accessway	Roof plant area			*					*			3	Highlight the pipe with safety paint.

Recommended action: Highlight the pipe with safety paint.
